Flood Control Project Maintenance
2009 Structure Summary Report
Overall Unit and Item Ratings

Reclamation District No. 2096 Wetherbee Lake

Wetherbee Lake Pumping Plant & Navigation Gate

Flood Control Project Maintenance**Unit Cover Sheet****2009 Pumping Plant Inspection Results****Reclamation District No. 2096 Wetherbee Lake**

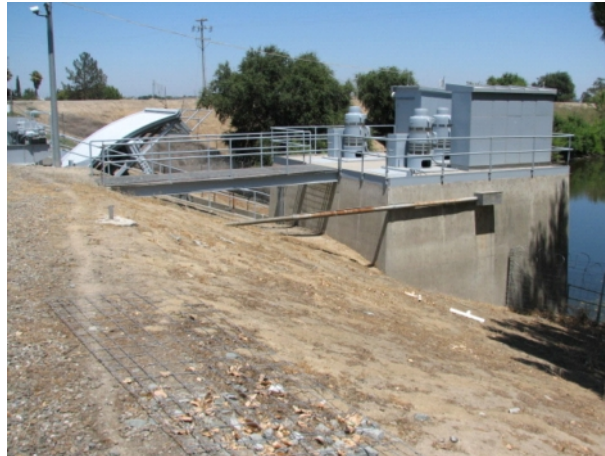
Levee Mile Report Line	3
Start Levee Mile	
End Levee Mile	
Location	
Category	Pump Stations
Item	Plant Building
Wetherbee Lake Pumping Plant & Navigation Gate	
jpaasch_20090716_4.jpg

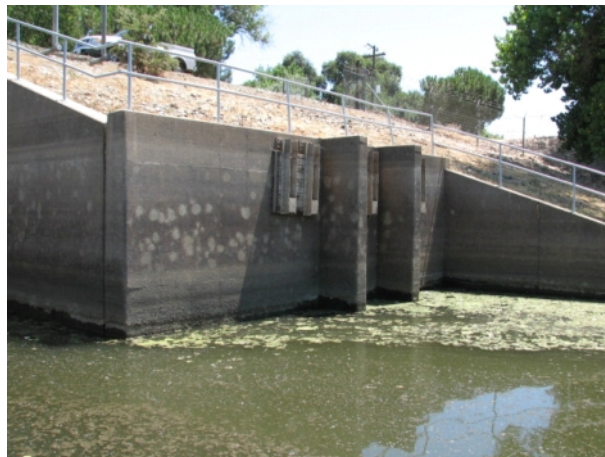
Levee Mile Report Line	18
Start Levee Mile	0.00
End Levee Mile	0.00
Location	
Category	Pump Stations
Item	Flap Gates
Photo of outfall structure headwall and three wooden flap gates. Gate on left missing hinge bolt.	
jpaasch_20090716_3.jpg

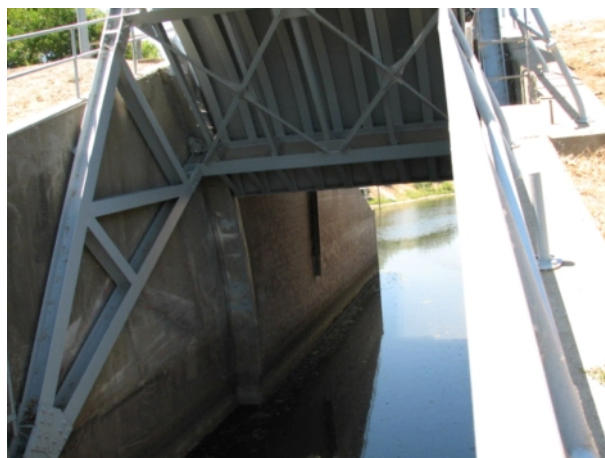
Levee Mile Report Line	19
Start Levee Mile	0.00
End Levee Mile	0.00
Location	
Category	Pump Stations
Item	Closure Structures
Navigation channel closed by radial arm gate.	
jpaasch_20090716_5.jpg

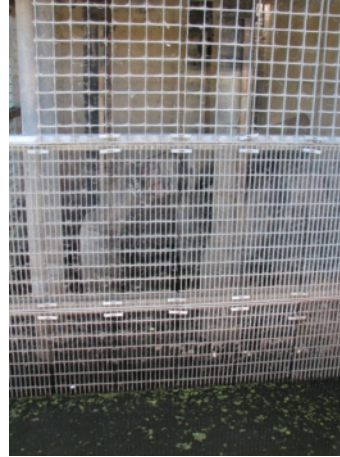
Levee Mile Report Line	21
Start Levee Mile	0.00
End Levee Mile	0.00
Location	
Category	Pump Stations
Item	Intake and Discharge Pipes
View of intake pipes, pump shafts and trash racks.	
jpaasch_20090716_6.jpg
